Manhole Inspection Summary

Manhole # S06GG2013MH

Insp Date: **7/29/06 8:18 AM**

Location Address: **3401 BONNIE RD**

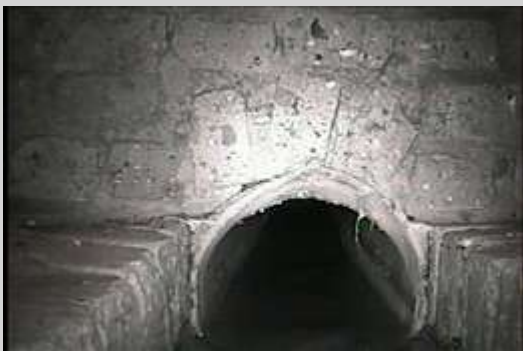
8 in. Circular Gravity Sewer Pipe In @ 4 O'Clock

Pipe Material: **Unknown** ☒ Pipe Lined

Infiltration: **None** Pipe Seal Cond: **Unknown**
